## THE DECAY OF TERTIARY SANDSTONE IN A NON-POLLUTED ENVIRONMENT: CARTA CISTERCIAN MONASTERY IN SIBIU COUNTY, ROMANIA

**Abstract:** Cârța Cistercian Monastery, built in the 13th century during the colonization of Transylvania by Saxons, is the oldest preserved monument in Romania built in the Cistercian style. Tertiary (Sarmatian) calcareous sandstones from the southern part of the Transylvanian Basin were used for construction. The sandstones, rich in quartz, feldspars and rock fragments, are feldspathic litharenites with carbonate cement and bioclasts having a very low porosity. These are not suitable as building stones due to the influence of the CaCO<sub>3</sub> and clay minerals content as opposed to the compact framework of the stone that does not allow expansions; micro fissures and dissolutions occur due to the chemical weathering. The low ultrasonic velocity proves granular disintegration of the sandstones, which presents a medium to high anisotropy. The weathering processes, macroscopically analyzed, belong to Discoloration/Deposits, Detachments, Loss of stone material, and Fissures/Deformations groups. The microscopic analysis evidenced specific weathering processes: fr

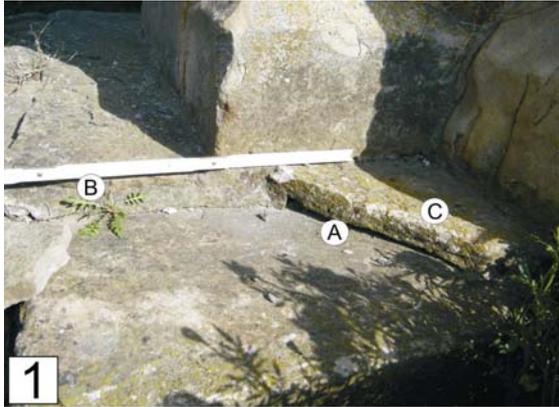
presence of the constant moisture (Plate 1, Fig. 1). The constant moisture changes the sandstone by expanding the clay minerals, causing stress and weakening the rock. On the geminate window and chapter house, these processes increase the overall permeability of the stone and generate weathering processes such as exfoliations, or granular disintegrations as flakes and multiple flakes to multiple scales (Plate 1, Fig. 6 and Plate 2, Fig. 5). The western parts of the portal (facade), the chapter house and the geminate window are also affected by insolation. This, combined with the dissolution of the carbonatic components of the sandstone are weakening the bonds between the minerals, creating micro-fissures. The hydration and insulation processes enlarge the original micro-fissures, thus creating larger pores. Subsequently, they lead to loss of material via detached crusts, weathering out, breaking out, and back weathering (Plate 1, Figs. 1, 5, and 6). On the western part of the portal the intense alveolar weathering of the sandstone led to disintegration into sand and to back weathering of the protruding architectural elements (Plate 1, Fig. 2). Depending on the rock structure, the micro-fissures resulted from the processes described above generate detachments of crusts and back weathering due to loss of crust and weathering out (Plate 1, Fig. 5). Moisture changes the sandstone by increasing the mineral compound structure during the re-hydration of dehydrated clay minerals, causing expansion (Ritchie, 1975), leading to stress and finally, weakening of the rock. These processes increase the overall permeability of the rock and generate weathering processes such as pitting (Plate 1, Fig. 4). Changes in color take place as well, as a consequence of hydrations or/and oxidations (Plate 1, Fig. 4). The intensive weathering is also influenced by the high anisotropy of the sandstones.

Figure 1. Detailed picture of the geminate window - western side. Microbial colonization (C) and colonization by higher plants (B) are visible on the blocks at the bottom of the windows. Yellow lichens settle on the hard sandstone. Also, back weathering due to loss of scales (A) occurs.

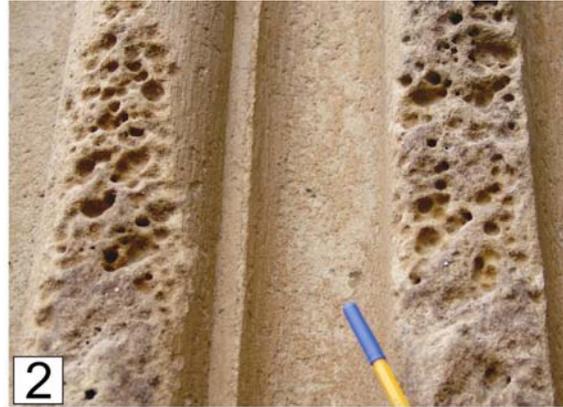
Figure 2. Detailed picture of the church's portal (facade) - western side. The intense alveolar weathering of the sandstone led to disintegration into sand and to back weathering of the protruding parts of the portal.

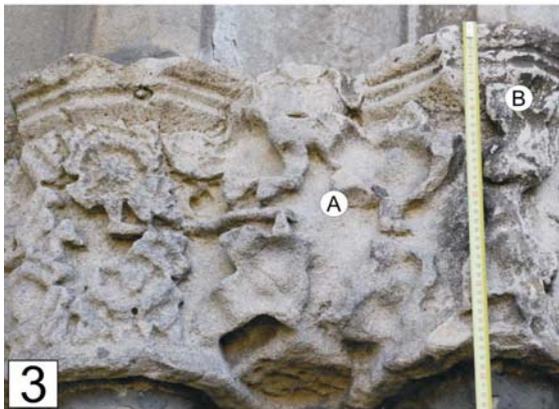
Figure 3. Detailed picture of the church's portal (façade, the frieze) - eastern part. The softer sandstone is disintegrating into sand and grains because of the weak bonds between the mineral grains, and inner dissolutions (A). Also superficial dark crust occurs locally (B).

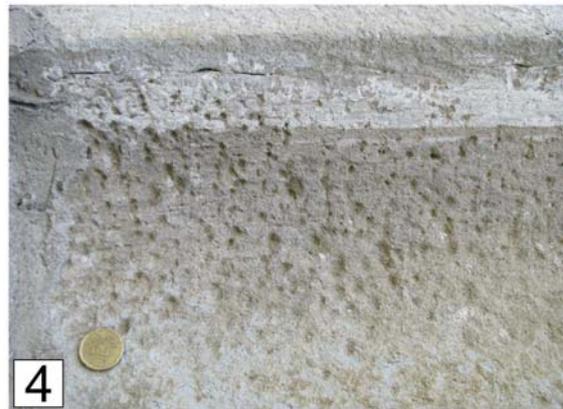
Figure 4. Detail picture of the church's portal (facade) - western side. The presence of constant moisture affects the sandstone by expanding the mineral aggregates?, causing stress and weakening the rock. This increases the overall permeability of the stone and generates weathering processes such as pitting (upper part) and flaking (bottom). Changes of color take place as well.

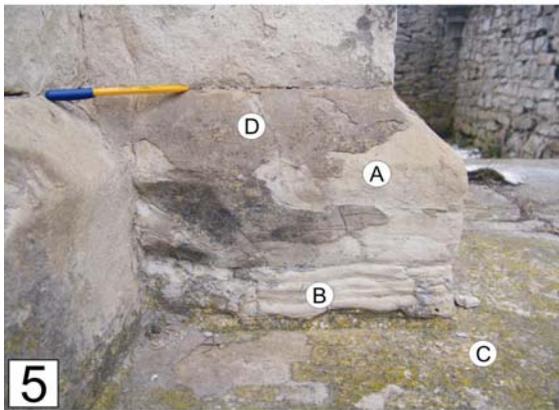
Figure 5. Detailed picture of the geminate window - western part. Intensive formation of dark-coloured crust tracing the surface (D) due to the high moisture. The detachment of the crusts leads to back weathering (A). Subsequently, new types of weathering can easily occur, depending on the rock structure (B). At the bottom, yellow and grey lichens cover the harder, and probably less porous, sandstone (C).

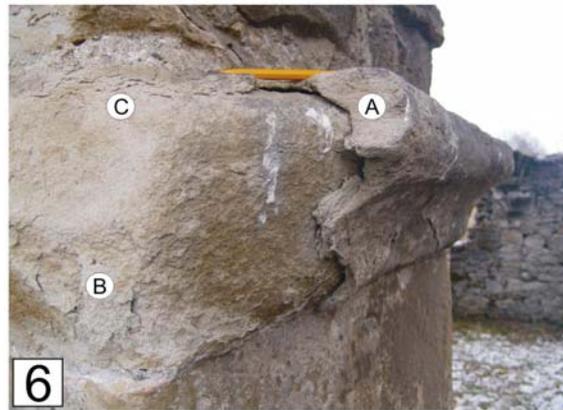
Figure 6. Detailed picture of the geminate window - western part. Intensive weathering of the weak sandstone, which lost large masses due to breaking out (A). Dissolution of calcite under constant high moisture led to surface spalling, as multiple flakes and scales (B). The consequence is the granular disintegration into single flakes (C).

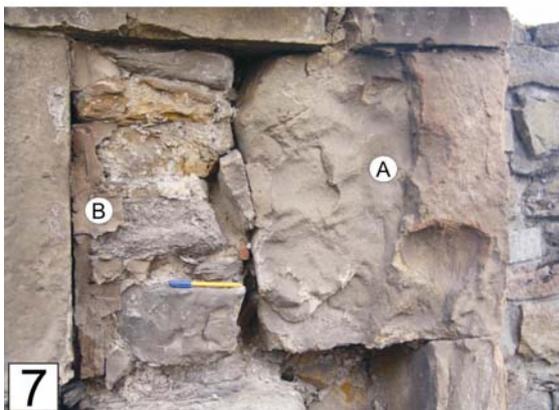
Figure 7. Detailed picture of the chapter house – the interior, eastern part. Large areas of the porous sandstone broke out along the internal microfissures developed parallel to the surface, generating crumbling disintegrations to single scales (A). The high moisture controls the formation of superficial, coloured crust (B). The decay continues with the smoothing of the block corners due to disintegrations resulting in rounding and notching processes.

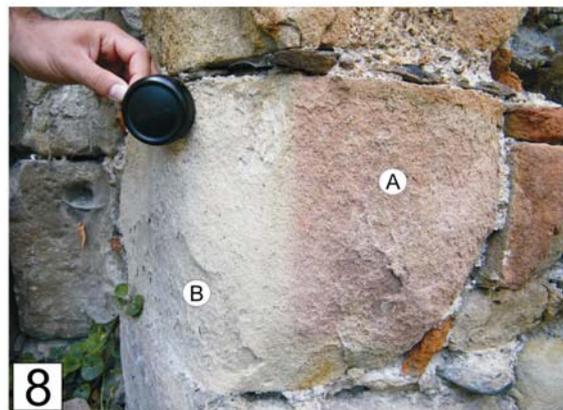
minerals) gives birth to red oxides, pigmenting the sandstone (Plate 1, Fig. 8). This process probably took place during an intensive fire that affected the monastery, when calcination occurred. Also, as a result of hydration, discoloration (bleaching) occurs on large areas on the blocks (Plate 2, Fig. 1). Oxidation can result in an increase of the mineral structure volume, thus the weakening of the rock, which later becomes granular and is disintegrated into grains and single flakes (Plate 1, Fig. 8 and Plate 2, Fig. 4). As result of disintegrations, large parts of the more porous sandstone are breaking out along the internal micro-fissures developed parallel to the surface. Also, crumbling disintegration to single scale products occur as indicated in Plate 1, figure 7 and Plate 2, figure 4. The decay continues with the smoothing of the blocks' corners, via rounding and notching processes (Plate 1, Fig. 7). As a consequence of their loss of structural integrity (by inside dissolutions, oxidations, hydrations and mechanical stress leading to the formation of large fissures), the sandstones are breaking out (Plate 1, Fig. 6 and Plate 2, Fig. 1). For example, higher plants and microbiological crusts colonize the chapter house blocks along the N-S direction (Plate 2, Fig. 2).

Figure 8. Detailed picture of the geminate window - eastern part. Oxidation processes of iron in Fe-rich phases (e.g., clay minerals) led to the formation of red oxide that pigment the sandstone (A). This process probably took place during an intensive fire, when calcination occurred. Oxidation can also cause increase in the volume of the mineral aggregate, thus weakening the stone, which later disintegrated into grains and single flakes (B)

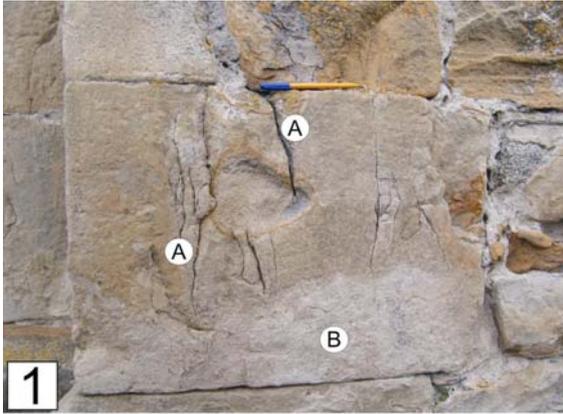
Figure 1. Detailed picture of the geminate window - eastern part. Large fissures (A) occur in the weaker, more porous sandstone from the bottom part of the wall due to inner dissolution and mechanical stress. Bleaching is noticeable on large parts of the blocks as result of hydration (B).

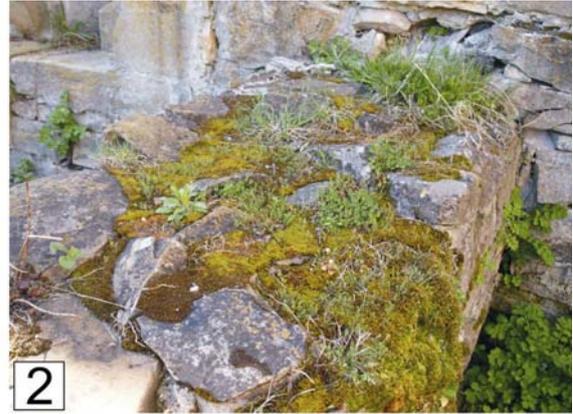
Figure 2. Detailed picture of the eastern wall of the chapter house. Along N-S direction, the lower part of the wall is colonized by higher plants and covered by microbiological crusts due to the constant moisture. Also, dark crust traces the surface of the non-colonized blocks.

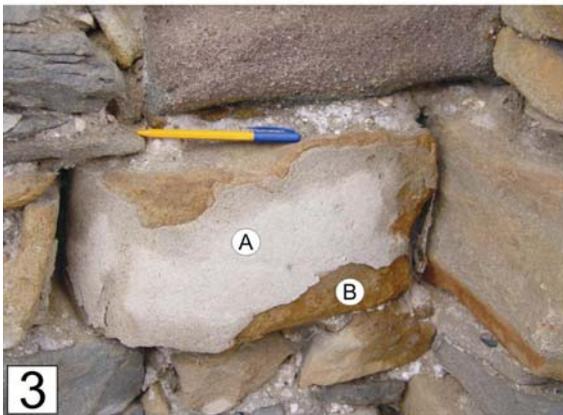
Figure 3. Detailed picture of the interior of the chapter house - eastern part. The high and constant moisture content at the bottom of the wall led to intensive calcite dissolution and implicitly to the formation of light-colored crust tracing the surface (A). The weakening of the bonds between the mineral components due to dissolution generates micro-fissures parallel to the surface, which result in the detachment of the light colored crust tracing the surface (B).

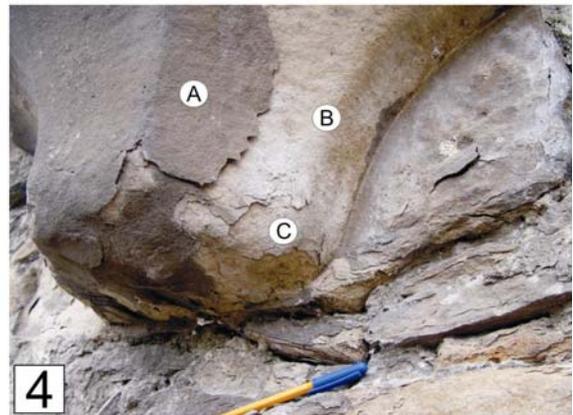
Figure 4. Detailed picture of the geminate window - eastern part. Due to the large amount of moisture from the rain water on the surface of the apparently more porous sandstone, dark-colored crust tracing the surface (A) occurs as result of inner dissolutions. The resulting micro-fissures parallel to the leading to the detachment of the superficial dark-colored crust (B). The decay process continues, and as consequence there is a loss of material, as multiple flakes (C).

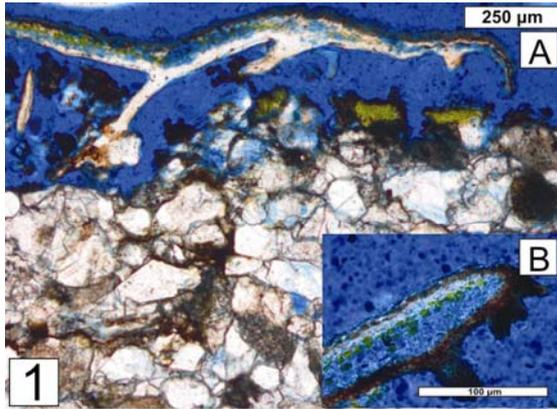
Figure 1. A. Geminata window sample - western side. The surface of the rock is covered by microbiological colonization by fungi and other microorganisms, leading to a thin carbonatic crust. The crust itself might document a former conservation attempt with silica ester (single polar). The intense blue color is due to the pigment added for enhancing the pores. B. Portal sample - eastern side. A more detailed image of a similar carbonatic brownish crust with a zone of secondary solution porosity (blue-stained) and round holes due to organic etching was formed parallel to the crust surface. Therein green lichens are settling (single polar).

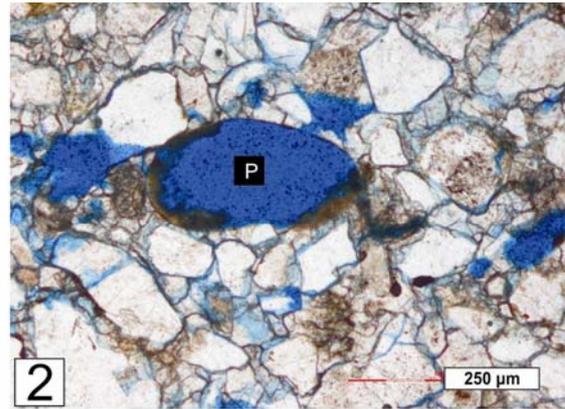
Figure 2. Portal sample. Low intergranular porosity and large pores (blue-stained) formed due to partial dissolution of carbonate grains. Dissolution was enforced by a fracture zone. The larger pore (P) probably formed by the break out of the central part of an ooid, as indicated by surrounding relics of ooid cortices (single polar).

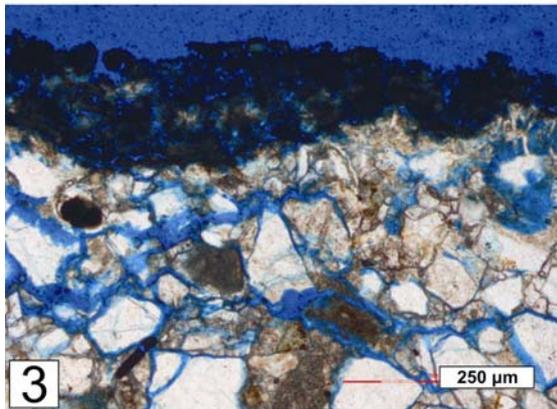
Figure 3. Geminata window sample - western side. A relatively thick layer of radial growing gypsum crystals is located at the surface of the building stone, probably representing dirt deposits or relics of some ancient paintings (single polar).

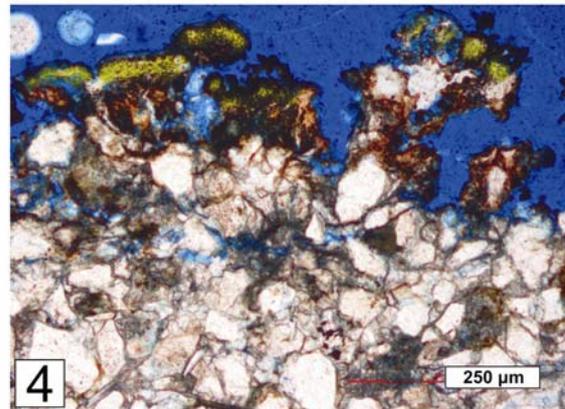
Figure 4. Geminata window sample - western side. Due to the high moisture in the lower part of the geminata window, a proper environment for microbiological colonization by fungi and lichens was developed (single polar).

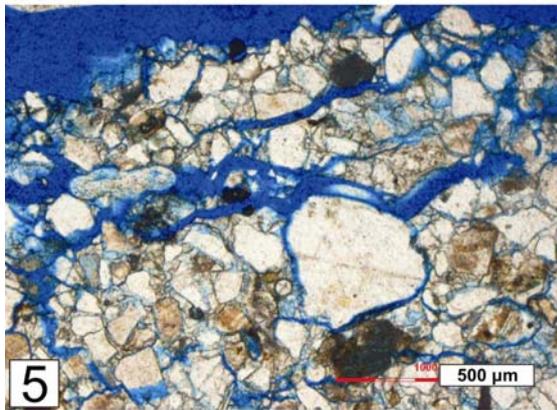
Figure 5. Portal sample. The small fractures parallel to the surface of the rock (blue-stained) and the dissolution of the matrix lead to the weathering process represented by detachment of multiple flakes (single polar).

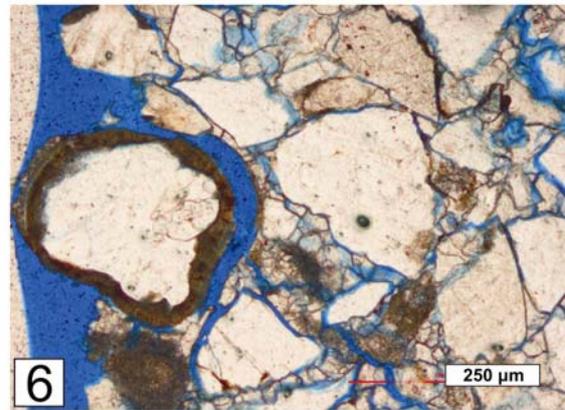
Figure 6. Portal sample. Abundant fractures and fissures (blue) network around grains due to dissolution of the rock matrix. The disintegration of the outer rock surface into grains/sand is one of the most important weathering processes in sandstones. Note ooid with a quartz grain as core expelled from the rock (single polar).

of the studied areas, especially on the western side, typical process of biological colonization by fungi and other microorganisms occur, mostly because the blocks are highly exposed to moisture. In some cases, moisture can lead to the formation of a thin carbonatic crust (Plate 3, Fig. 1A). In a more detailed image of such a crust (Plate 3, Fig. 1B), a zone of secondary solution porosity (blue-stained) and round holes due to organic etching can be seen. These are formed parallel to the crust surface allowing green lichens to settle inside. A thicker layer of lichens and fungi colonization occurs at the surface of the samples collected from the lowermost part of the geminate window (Plate 3, Fig. 4). Thick black crust deposits also occur (Plate 3, Fig. 3). The radially growing small crystals might be gypsum, as this is the regular secondary product of calcite dissolution in similar crusts. Some other, thinner black-brownish deposits identified on a sample from the eastern side of the geminate window may be interpreted as relicts from ancient paintings (Plate 3, Fig. 7). Because of crust development, fractures parallel to the rock's surface may occur, weakening its structure. Flaking is one of the most frequent weathering forms identified in situ. The process consists of the detachment of small, thin rock layers (flakes) parallel to the stone surface. Small fractures (blue stained) parallel to the surface lead to the detachment by flaking (Plate 3, Fig. 5). Another detachment weathering process is the granular disintegration into sand and/or grains. Probably due to the dissolution of the carbonate cement, fractures and fissures occur at the surface and run around individual grains (Plate 3, Fig. 6).

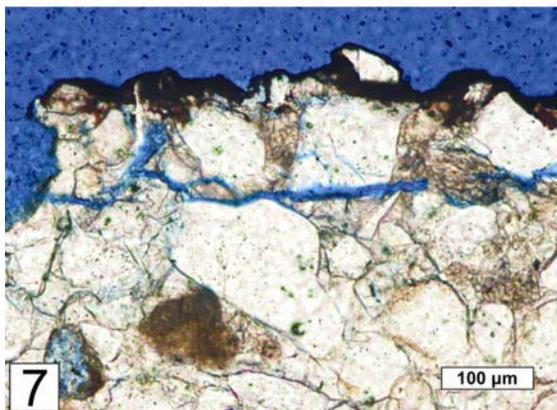
Figure 7. Geminata window sample - eastern side. Relic of historical painting or a previous attempt of conservation builds up as a thin crust visible as dark colored (black/brownish) deposits on the surface of the sandstone. The harder, elastic crust could weaken the rock and lead to the formation of fractures parallel to the surface (single polar).

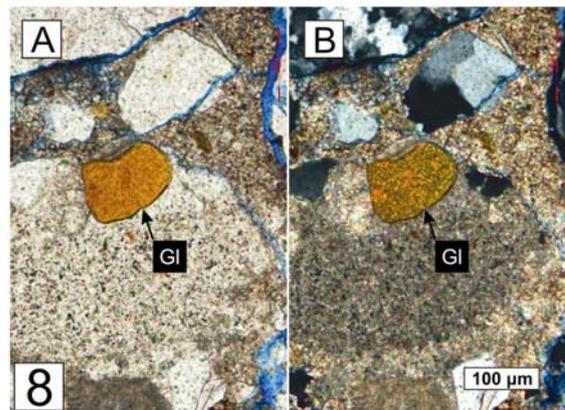
Figure 8. Portal sample. Although glauconite (G1) is scarce in the analyzed sandstone, it bears important features such as the brown color of the grain. This might indicate heat damage related to historical firing that occurred inside the former abbey (A - single polar), (B - cross polars).
