VULNERABILITY OF SLOPING LANDS, UNDER DYNAMIC CONDITIONS

Florentina PASCARIU

Abstract: During recent years, a series of civil construction works have been started on all slopes from Iași Municipality. This study aims to analyse the stability of a perimeter from a southern slope of the city, in the area of Mihai Ciucă Street, Iași. For the development of a GF + 1 construction (ground floor and first floor) in this area geotechnical surveys were performed and soil samples were taken, which have been analysed by specific geotechnical methods. Starting from the values of the physical-mechanical parameters of the rocks, respectively from the aspects regarding the terrain geometry, different simulations were performed in order to identify its stability factor. These simulations took into account the presence or absence of construction, the existence of the current groundwater level or of a level close to the surface, as well as of the possibility of the occurrence of an earthquake. When we start from the hypothesis according to which all three factors act simultaneously on the researched land (the given construction load, the high groundwater level / current groundwater level and the e

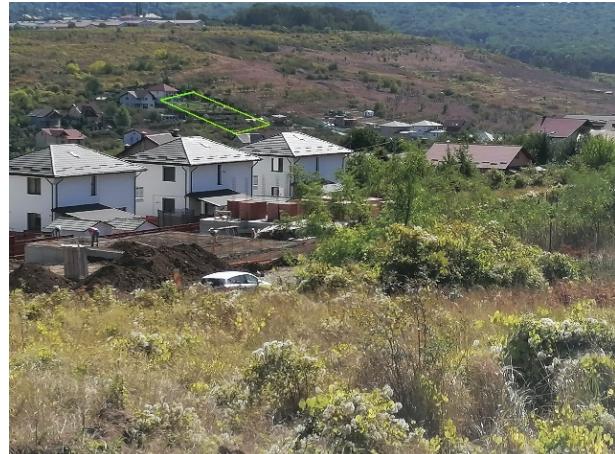
Figure 2. Detailed view of the researched area.

The choice to study the stability of a southern slope of the city of Iași appeared as a consequence of the performance of two drillings in the area of interest, made for a geotechnical study aimed at building a house with ground floor and first floor (Fig. 1, 2). This paper aims to develop some estimates regarding the local stability of this buildable location, in the area of Mihai Ciucă Street, Iași (Fig. 1). The analysis was performed starting from the physical and mechanical characteristics of the rocks encountered in this perimeter, respectively making some direct observations. The paper presents different simulations using the Bishop method, which involves the participation in the slope processes of the most important active factors: water, earthquake and land overload.

The researched area is located on the Racoviță Coast, in the southern part of the geomorphological unit Culoarul Bahlui, belonging to the Moldavian Plain (Băcăuanu, 1968). The hill has an average slope of 20% and has on its surface, for the time being, only a small number of houses built (Fig. 2).

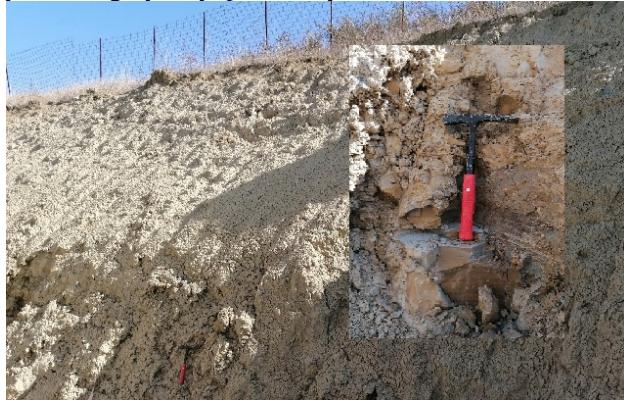
Figure 3. Detail with the collection point of samples PP3 and PP4.

The clays from which the four samples were collected have a layered appearance, are generally yellow in colour and are fairly well compacted. At the base of the outcrop, from the area on the property from the vicinity of the study area, we find grey clays with small grains of sand (Fig. 3, 4). The analysed samples reveal a relatively low content of microfossils, distributed according to the table 1.
