APPLICATION OF REMOTE SENSING IN THE RED MUD ENVIRONMENTAL DISASTER IN HUNGARY

Abstract: Data collection with the help of remote sensing is significant in the field of information about the environment quickly and effectively. In case of the red mud disaster in Ajka, Hungary Oct. 4, 2010 our group of researchers carried out an extensive remote sensing data collection with the coordination of Science Council of the Committee of the Government Coordination Commission, applying the most up-to-date technologies of remote sensing and data processing. In this publication besides the main points in planning and executing air shots we also summarize the results of data processing with image analysis during the evaluation of the catastrophe and the compensation period.

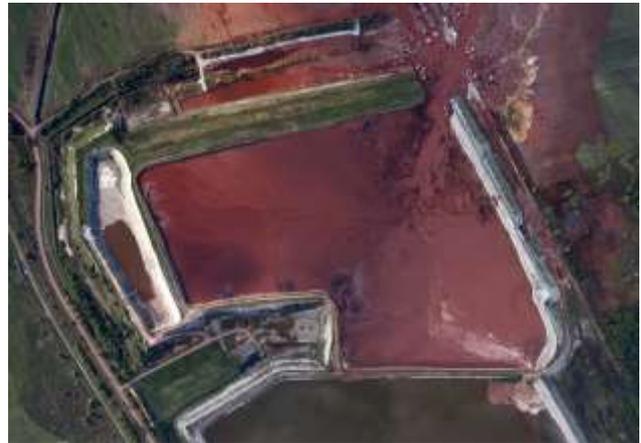
Figure 3. Localization of cracks, breaks and slivering in high resolution visible image

Based on the air-shots we have defined the movements involving the Northern wall of the dam together with their causes and we have localized the cut-off points and the slivering of the wall (Fig. 3).

We have quickly identified the wet, leaking areas and mechanism of the cracks in the images shot near the reservoir. During the lateral examination of the dam wall we studied clues alluding to cracks and leaks (Fig. 3, Fig. 4 and Fig. 5).

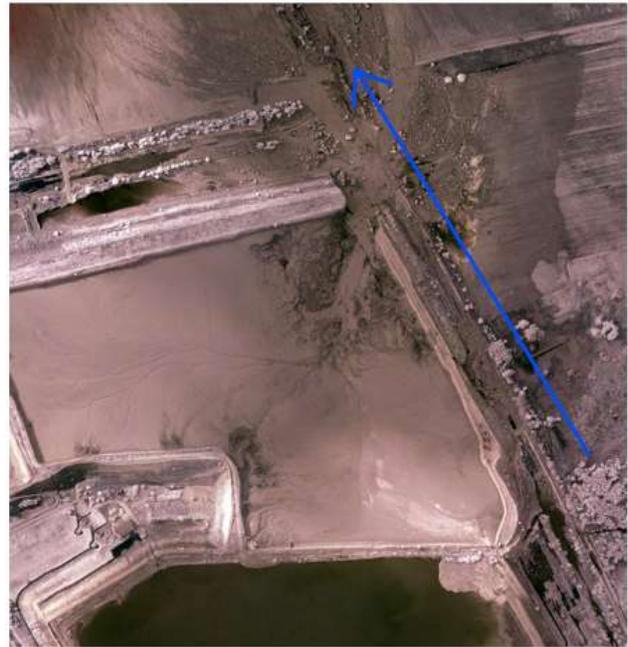
Figure 5. Signs of wetness near the northern dam section in NIR air-shot /with the arrow showing the direction of slope/

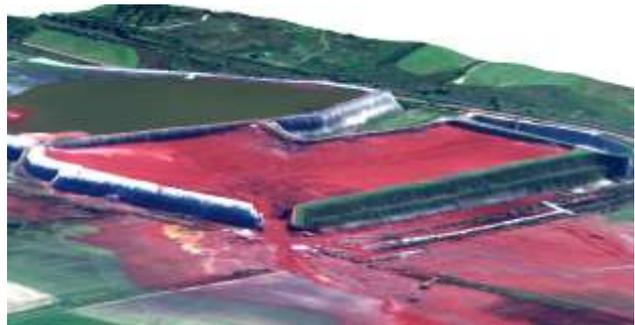
Figure 6. The LIDAR image used for the definition of the amount of mud having flooded out of the reservoir

The area after the tear of the barrier wall was given by a measurement with LIDAR technology (Fig. 6). The volume between the two areas was defined by their intersection. The 'reconstruction' of the broken piece of wall was also made based on the shots above. We have also defined the cross-section and longitudinal section of the reservoir.

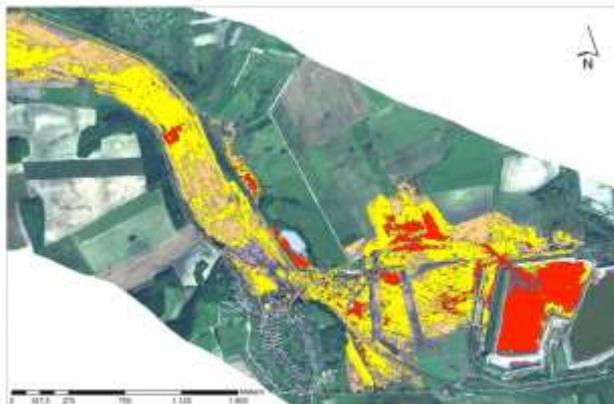
Figure 8. Field samples (red mud thickness) and RMLI data on the examined cross-section of flooded area (blue dots: red mud thickness (cm) of field samples, red line: RMLI).

we defined the threshold values for 4 thickness categories of previously marked areas (Fig. 7 and Fig. 8).
