CHANGES IN BATHYMETRY AND LAND COVER OF RIPARIAN ZONE OF AN OLD ARTIFICIAL WATER RESERVOIR VEĽKÝ KOLPAŠKÝ

Abstract: The mining region of Banská Štiavnica (Slovakia) has been inscribed into the UNESCO List of the World and Cultural Heritage in 1993. One of its special features is the system of artificial water reservoirs (locally referred to as “tajchy”) communicating via trenches built in early 18th century. The system was a water source, which drove the mining machines. Accumulation and transfer of sediments mainly depending on changes of land cover in the riparian zone leads to the loss of retention capacity and reduced life of reservoirs. Aim of this study is to analyse changes of the storage capacity/volume of the Veľká Kolpašská water reservoir that took place in the last 123 years (1889–2012) and changes of land cover (LC) on the riparian zone in the course of the last 63 years (1949–2012). Volume and bottom relief changes were identified by comparison of bathymetric data drawn from the historical map of 1889 with the present data obtained in 2012 by bathymetric surveying. 3D models representing different situations were used for computation of the sediment volume. Results s

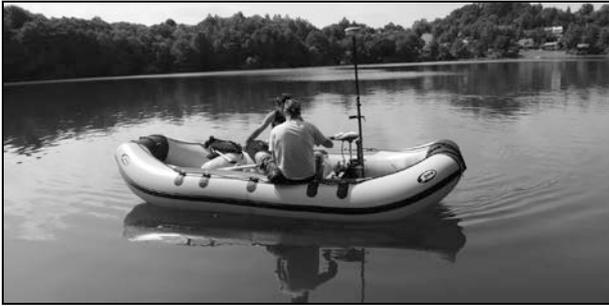
Figure 2. Data obtaining by means of direct measuring from vessel

Field research of the Veľká Kolpašská reservoir took place in on 23 and 24 May 2012. Depth was measured by a double-beam sonar and it was accomplished directly from the vessel using the following instruments: 1. Humminbird 717 (20° or 60° beams, frequency 200 & 83 kHz, quoted precision ± 10cm), and 2. External GPS (Fig. 2.) The measured step was 5 m.
