PETROARCHAEOLOGICAL STUDY OF MEDIEVAL RUINS OF BZOVÍK FORTIFIED MONASTERY

Abstract: The article represents the results of the complex petroarcheological study focused on the building material with respect to the restoration of the old fortified monastery Bzovík (Central Slovakia). The aim of the study was to determine the original building material and to suggest the best solutions of the building recovery. The petroarcheological study enabled to describe the present state of the used rocks, their resistance and several types of mortars. The aim of the study was determining the material of building. We found that the majority of the building stones are from the Neogene volcanics of the Štiavnica stratovolcano. Mainly effusive and extrusive activity of andesite volcanism. Distinguish the original and more new additional building elements, suggest suitable procedures and materials with respect to the sanitation of the building complex.

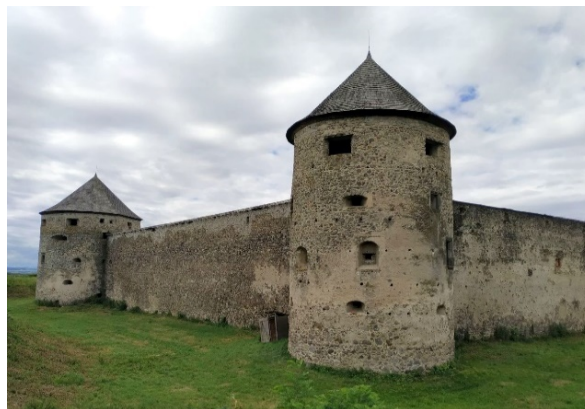
Figure 1. The Bzovík fortified cloister

The fortified monastery in Bzovík (Figure 1), dedicated to St. Stephen the King, is one of the oldest church institutions in Slovakia. In the years 1127–1131, it was founded as a Benedictine abbey by Lampert. Between 1180 and 1181, the Benedictines were replaced by the Premonstratensians, who lived in the monastery until 1530. In the 15th century, a monastery building with a courtyard and a cloister in the Gothic style was added to the Romanesque twin-towered church. The original Romanesque structure of the church and monastery was only partially destroyed by the Gothic modification (Borovszky, 1906).

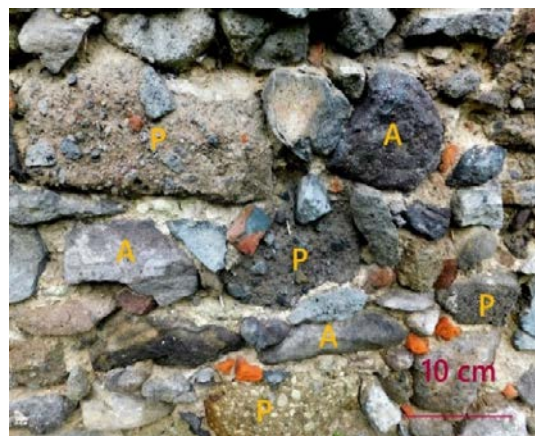
The monastery complex was built from different local materials (Figure 2). Parts of the complex (especially the fortifications) are built of andesite, which is in good condition even after centuries. Formation is a

Figure 2. The wall of the cloister: andesites (A) and pyroclastic material (P)

The building material of the monastery, which was built from different materials: sandstone, rhyolite, tuffs (pyroclastic rocks), and andesite, is more susceptible to weathering (Figure 2). Gray sandstones (Figure 3a) are relatively resistant to weathering. Yellow sandstones are somewhat less resistant to weathering (Figure 3b). These can be preserved using normal restoration procedures. Coarse-grained pyroclastic rocks weather the fastest (Figure 4 b, c). Parts of masonry built from this type of stone are irreparably damaged. Without interfering with the nature of the masonry, these pieces of stone can be replaced with the same type of rock, which is finer-grained and shows a significantly higher degree of resistance to weathering processes (Figure 4 a, 5).

centuries. This type of masonry does not require, except for local strengthening of loosened mortar, more serious reconstruction interventions. It is most suitable for reconstruction work to use an original type of material, consisting of lime and sand, for plastering and for binding stone parts of the masonry, which is functional even after centuries and which has demonstrated an extremely good ability to bond with the masonry.

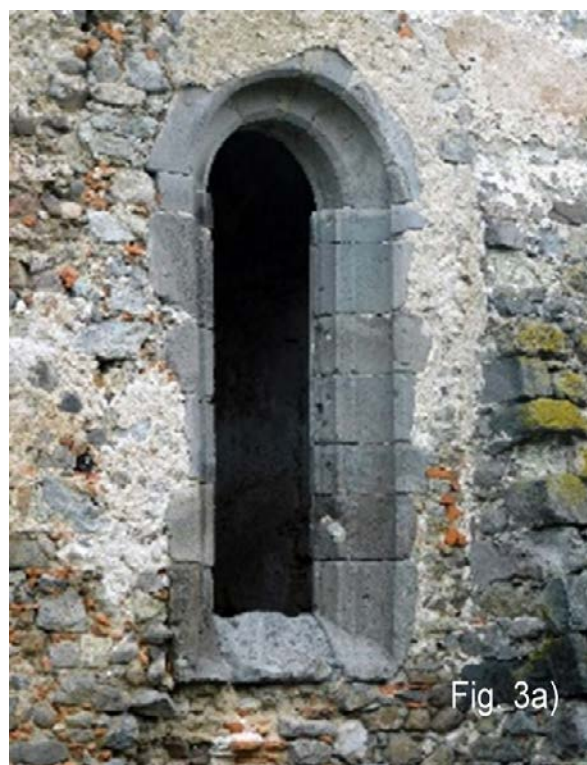
Fig. 3a)

Figure 3. a. The sandstone lining of the Gothic window in wall of the chapel; b. the sandstone lining of the niche in the wall of the fortification

This type of masonry does not require, except for local strengthening of loosened mortar, more serious reconstruction interventions. Gray sandstones (Figure 3a) are relatively resistant to weathering. Yellow sandstones are less resistant (Figure 3b).

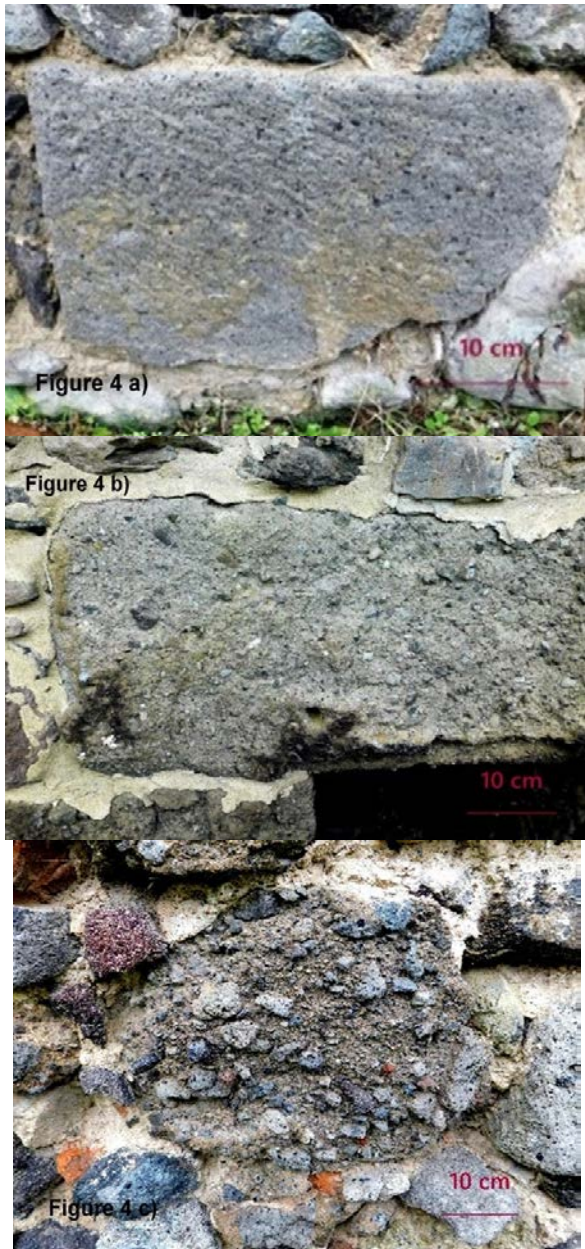
Figure 4. Types of pyroclastic rocks: a) fine-grained, b) coarse-grained, c) conglomerates

Coarse-grained pyroclastic rocks weather the fastest (Figure 4a). Parts of masonry built from this type of stone are heavily damaged. Finer-grained varieties show a significantly higher degree of resistance to

weathering processes (Figure 4b,c).

It is appropriate to use the original materials for the repair of the buildings, but select for this work the most resistant types of the rocks (e. g. not coarse grained but fine-grained pyroclastic rocks) and the original composition of mortars.

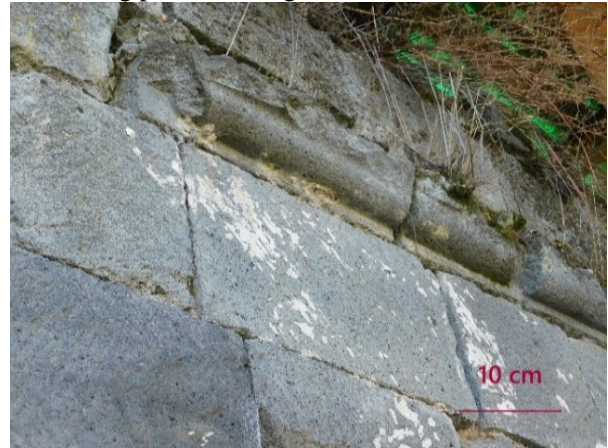
Figure 5. Details of the rest of a wall of the Cistercian Abbey built from carved pyroclastic rocks

Most stones are not chiselled, but some little portions of the stones were carved, e.g. details of linings (Figure 5) or several walls of the monastery. The most weathered material is represented by coarse-grained pyroclastic rocks (Figure 4c) and the most resistant are the andesite rocks (Figure 6).

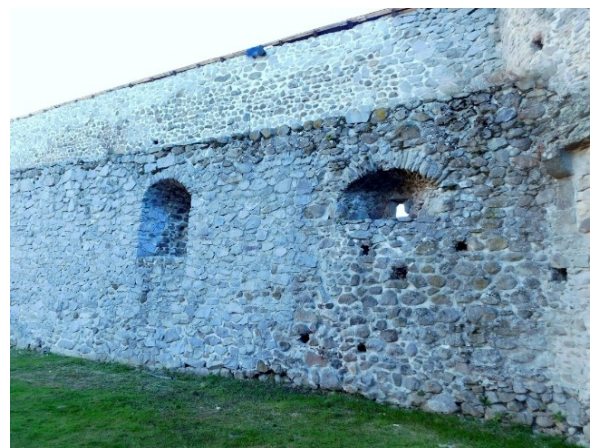
Figure 6. The fortification is built by andesitic rocks

Parts of the complex (especially the fortifications) are built of andesite, which is in good condition even after

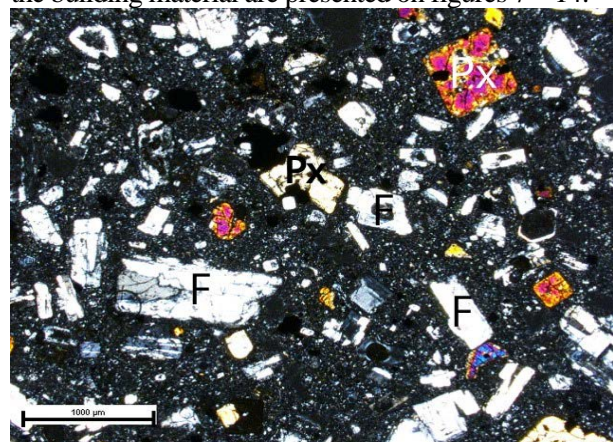
Figure 7. Altered dacite, vitreous matrix is strongly devitrificated. In the matrix are visible phenocrysts of feldspars - F and pyroxenes - Px (crossed polars).

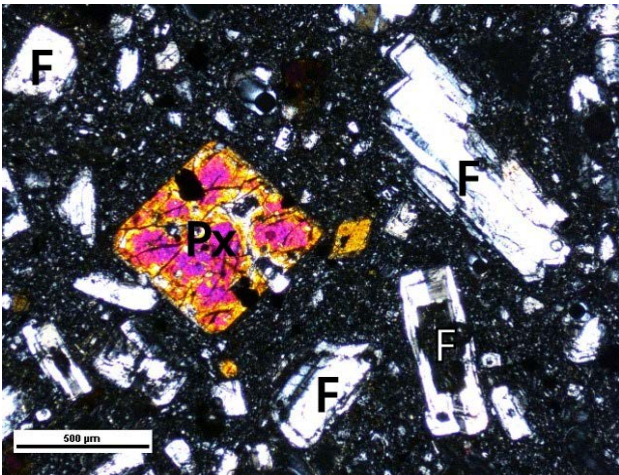
Figure 8. Detail of feldspars (F) and pyroxene (Px) phenocrysts (crossed polars) in andesite

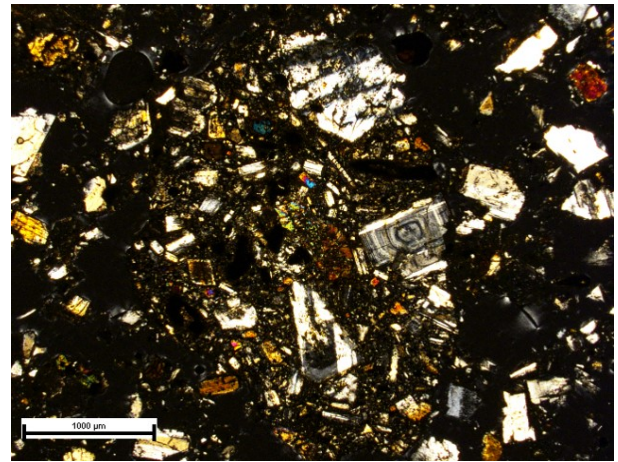
Figure 9. Ignimbrite (caked fragments) of andesitic rocks and of fine-grained ash. In fragments are visible zonal feldspars and pyroxenes (crossed polars)

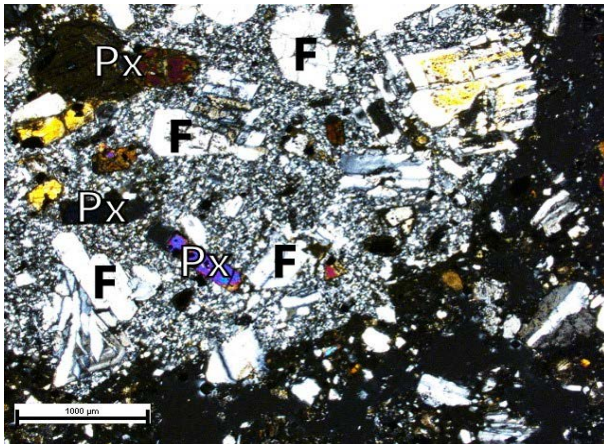
Figure 10. Ignimbrite - caked fragments of dacitic rocks and of fine-grained ash. In fragments are visible zonal feldspars - F and pyroxenes - Px (crossed polars).

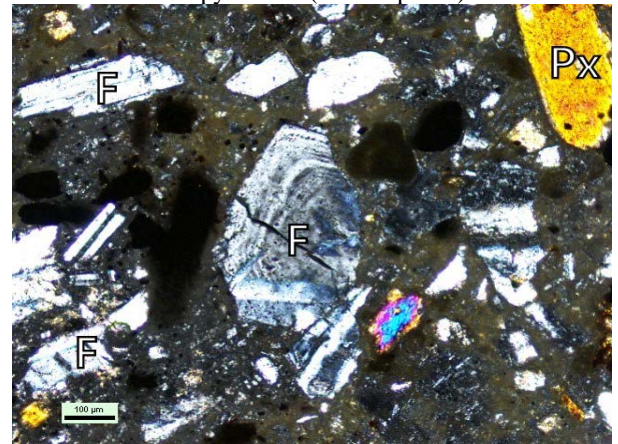
Figure 11 a) Fragments of feldspars (F) and pyroxenes (Px) in devitrificated matrix (crossed polars); b) Rhyolitic tuf with prevailing vitreous matrix; detail of feldspar fragments (crossed polars).

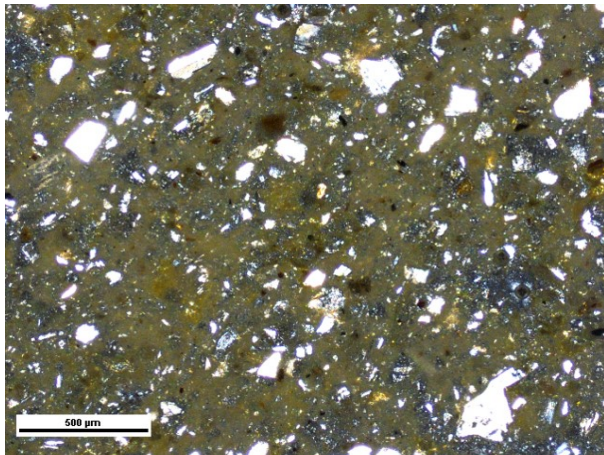
Figure 12. Rhyolitic tuff with prevailing vitreous matrix (crossed polars)

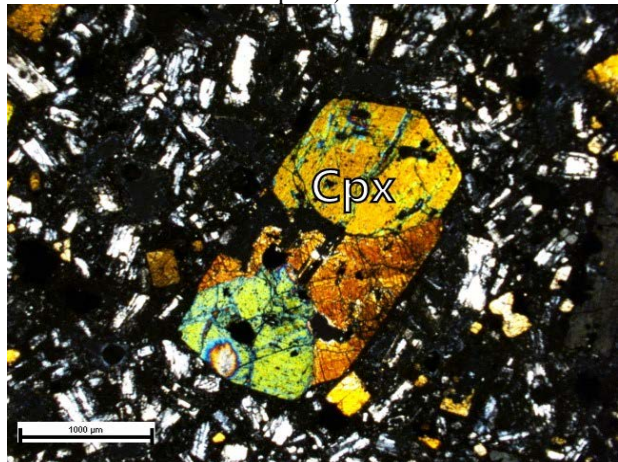
Figure 13 Phenocryst of zonal clinopyroxene (Cpx) in andesite with nice example of hourglass texture (crossed polars).

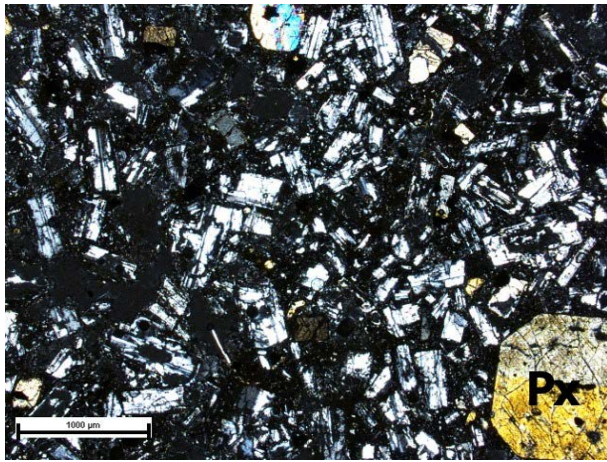
Figure 14. Ophitic texture of andesite with pyroxene phenocryst (Px) (crossed polars)

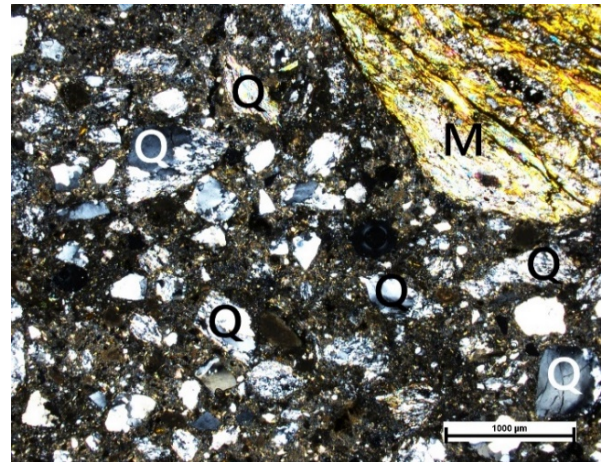
very nice example of such a mortar is the mortar sample presented in Figure 16. The substantial part of the sample consists of quartz, feldspar (basic plagioclase andesine), and calcite from local sources (derived from surrounding volcanic rocks). Less important admixtures are represented by hornblende (amphibole) and of various

Figure 16 Mortar sample containing fine-grained quartz grains (Q) and mica (M) (crossed polars)

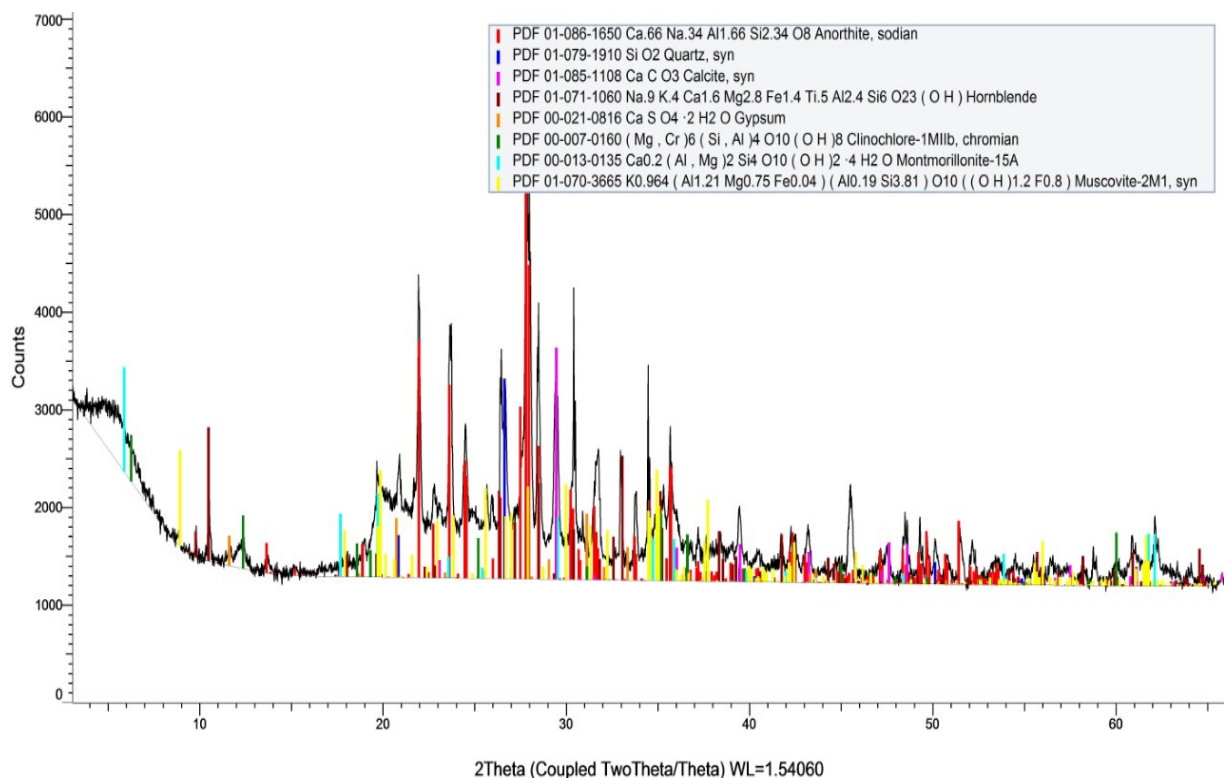
The oldest Medieval mortar is of a sand and slaked lime – $\text{Ca}(\text{OH})_2$ composition (Figure 15). The lime from various lime factories had different quality. A

phyllosilicates (chlorite, montmorillonite and muscovite). Also accessory presence of gypsum was proved (Figure 15). It could be formed by secondary processes (from sulfides) or could be added to the mixture with the intent to accelerate the duration of the mortar.

Figure 15. X-ray diffractogram of the oldest Medieval mortar.

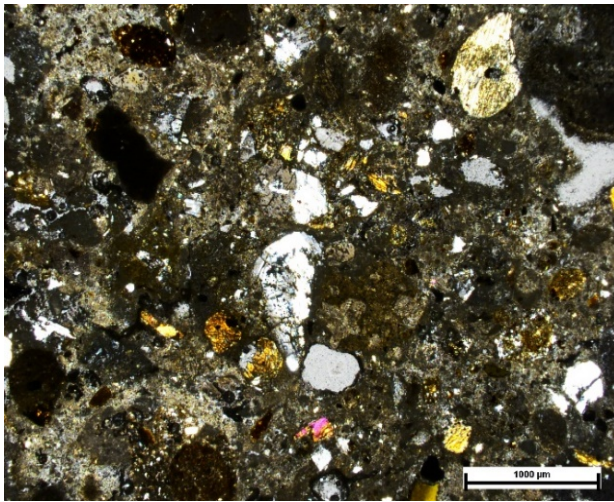
The next mortar type is different. It contains a predominantly aphanitic matrix with the addition of fragmental material (Figure 18). It is possible to identify zonal feldspars and clinopyroxenes in volcanic rocks. The rolled fragments indicate that they were transported from some faraway locality. Fragments of sedimentary rocks are rare.

Figure 17. Aphanitic rock-material in the mortar (crossed polars).

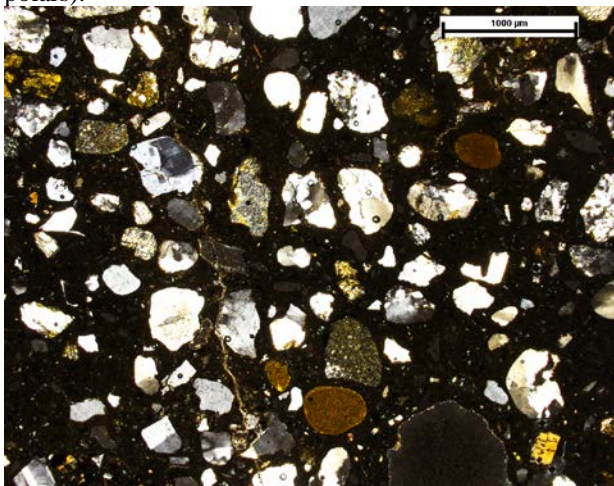
The mortar from the second half of the 20th century consists of a fine-grained matrix with sharp-shaped grains of undulatory quartz (Figure 19). Besides quartz, there are greater grains of feldspar and fragments of volcanic rocks. Great, partly rounded clasts of fine-grained quartz and volcanites are rarely visible. The

Figure 19. Fine-grained matrix of mortar with sharp grains of undulatory quartz (crossed polars).

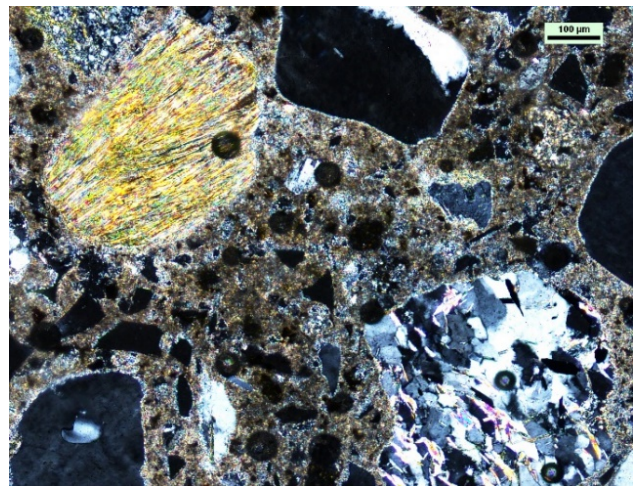
Figure 20. Sharp feldspar and gneiss fragments with a fragment of mica (yellow; crossed polars).

The mortar in other samples from the same time has approximately the same character. The material consists of a fine-grained matrix with sharp grains of undulatory quartz (Figure 20). The rate of crispness in the material is about 50:50. Besides quartz, there are also greater grains of sharp feldspar and gneiss fragments and locally also by mica-sandstones (Figure 21).

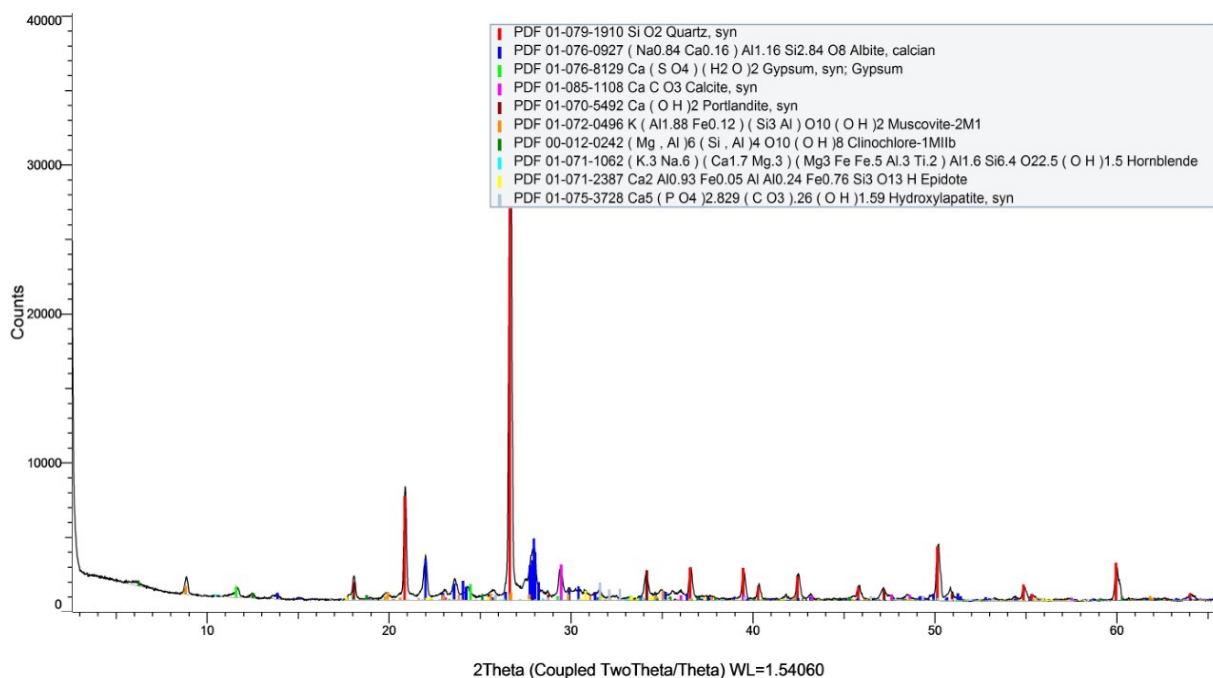
The X-ray diffraction analysis shows that in the mortar sample presented in Figure 21 there is dominant quartz, plagioclase (mainly albite), and calcite portlandite - a calcite in mixture with lime and portlandite. As accessory minerals, there are also hornblende (amphibole) and various phyllosilicates (chlorite and muscovite). The sand is relatively well culled and contains more or less only quartz. The presence of apatite grains, which are because of their high weight usually accumulated in water sediments, indicate that it is most probably a river-sand. Gypsum is probably of the same origin as in the mortar from the above mentioned Medieval sample.

Figure 21 X-ray diffractogram of the mortar from 20th century
